How to Prevent Electrical Pitting Damage

Electrical pitting damage, caused by intermediate arcing between stationary and rotating machine components, erodes the babbitted surface of a bearing, causing it to fail. With the right precautions, however, this type of damage can be prevented.

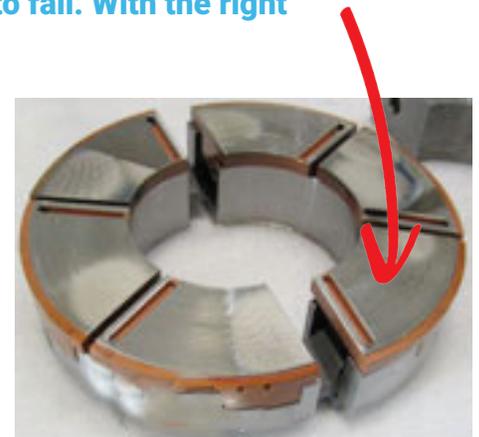
Figure 1

In this example of a steam turbine application, the consequences of erratic thrust pad temperatures were not obvious until the bearing was removed from the machine. In this case, the normal pad temperature was 95° C for a 10½", 6 x 6 LEG thrust bearing operating at 5700 RPM. The pad temperatures had been rising steadily for several days when suddenly the temperature of one pad shot up to 118° C and the other to 103° C. A few days later, the pad temperatures dropped back to 111° C and 92° C.

When the bearing was removed from the machine, all thrust pads showed signs of distress, as shown in Figure 1.

- Install grounding or earthing brushes on the rotor.
- Insulate the bearings to interrupt current flow.
- Investigate and eliminate the source of stray electrical current.

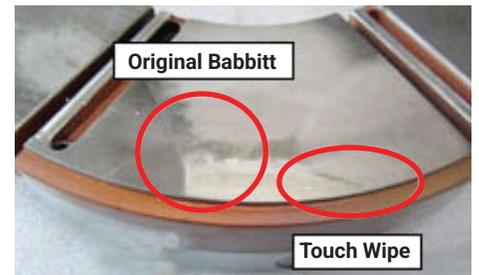
Figure 2

In Figure 2, the original babbitt remains only at the leading edge of the shoe. Evidence of wiping is visible toward the outer edge. Clusters of small pitted marks appear at the trailing edge and near the inner diameter at the leading edge.

Figures 8 and 9 show similar signs of burned oil in the contact area between the shoe's inner diameter and the base ring. The small pit marks and surface frosting observed on the shoes are classic indicators of electrical pitting damage.

This damage is caused by intermittent arcing between stationary and rotating machine components. Electrical current follows the path of least resistance, which is typically through the thin oil films in the active, loaded thrust bearing. Pitting damage initiates at the trailing edge of the shoe, where oil film thickness is smallest.

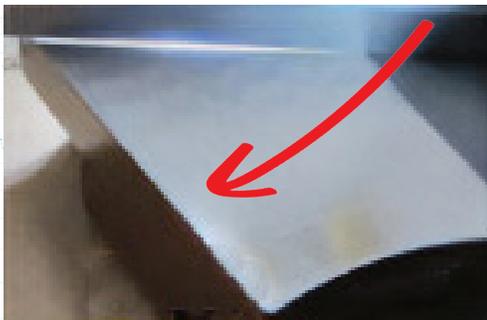
Figure 3 shows a significant loss of babbitt toward the shoe's trailing edge.

As electrical currents remove babbitt material, the shoe tilt changes, reducing the effective load-carrying area. The damage then progresses gradually toward the leading edge of the shoe. Eventually, the bearing can no longer support the applied load and wiping occurs.

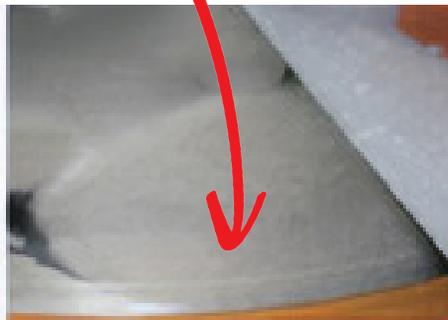
Figure 4 shows a closer view of the pitted marks. Note how they appear frosted. The babbitt is nearly gone at the trailing edge of the shoe as shown in Figure 5.

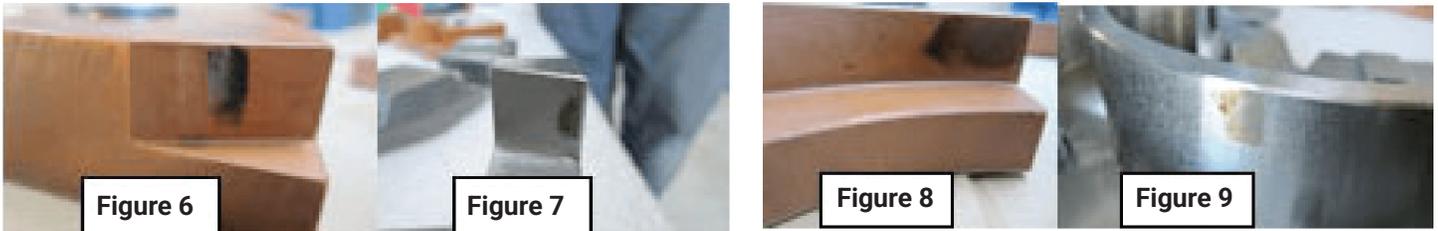
Figures 6 and 7 show evidence of burned oil in the contact area between the shoe's straddle mill and the base ring.
