Condition Monitoring of PEEK Bearings

Using Temperature Measurements

Gokaltun S^a, Fabijonas BR^a and Rodzvic RC^a

a Kingsbury Inc., 10385 Drummond Rd, Philadelphia, PA 19154, USA.

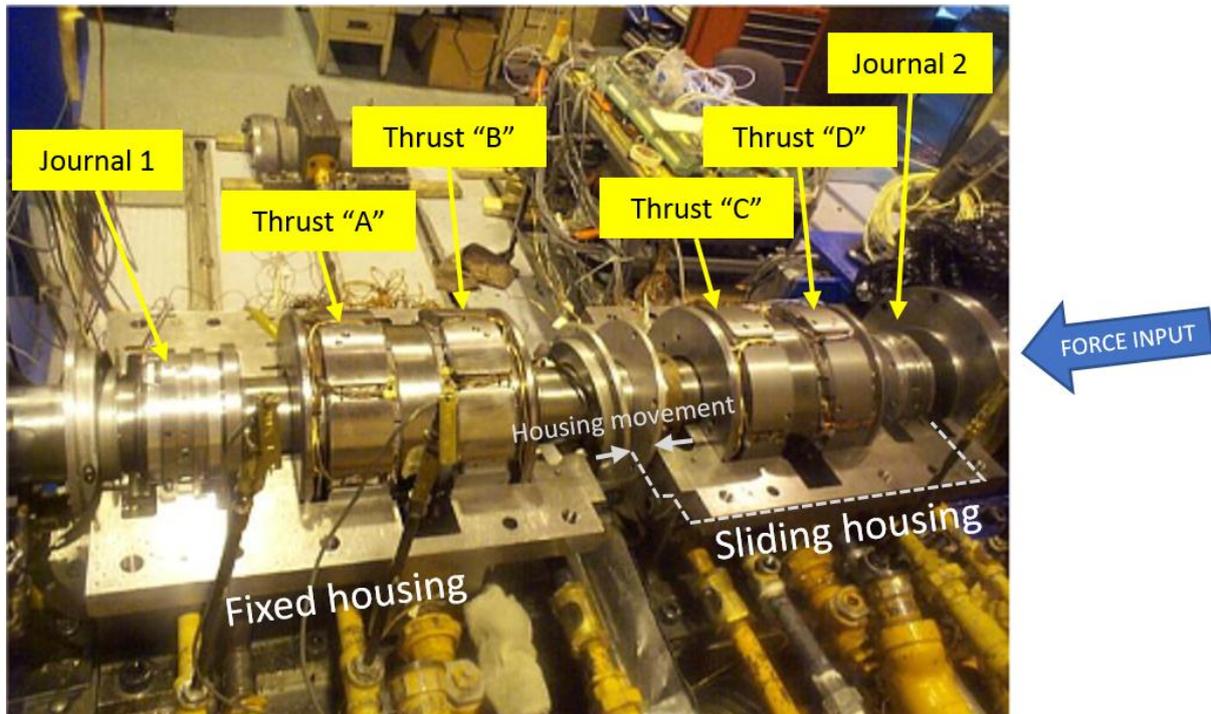
Figure 1. High speed test rig with upper half of the housings removed.

The high-speed test rig was designed to test two double-acting thrust bearings under load. Referring to Figure 1, the fixed housing adjacent to the turbine is firmly secured to the foundation while the sliding housing is restrained but is free to slide axially under rails. An external hydraulic system applies an axial load to the sliding housing. As a result, thrust bearings "A" and "D" are loaded against each other while thrust bearings "B" and "C" remain unloaded. A load cell mounted at the interface of the hydraulic system and the sliding housing measures the applied force. The bearings are carefully shimmed to set the axial clearance and to hold the position of the shaft so that no axial force is transmitted through the coupling to the turbine.

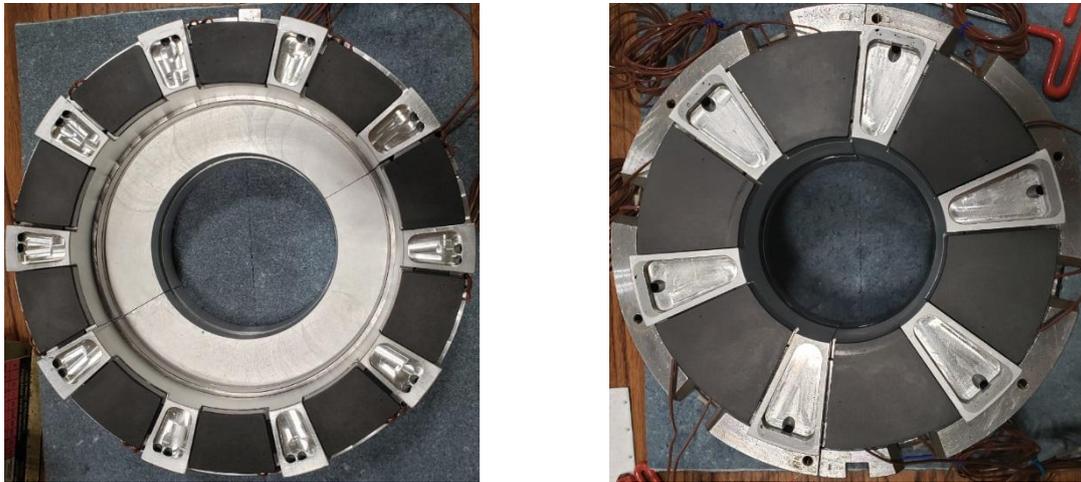
Figure 2. Pictures of the PEEK thrust bearings used in the "A" (left figure) and "D" (right figure) positions.

The four thrust bearings installed in the high-speed test rig are described in Table 1, and the operating conditions are given in Table 2. Pictures of the loaded bearings "A" and "D", which are the focus of this paper are shown in Figure 2. A National Instruments™ LabVIEW data acquisition system was used to record the test data. Steady-state measurements include shaft speed, applied thrust load, oil flow, oil supply pressures, oil supply temperature, oil drain temperatures, and pad temperatures.

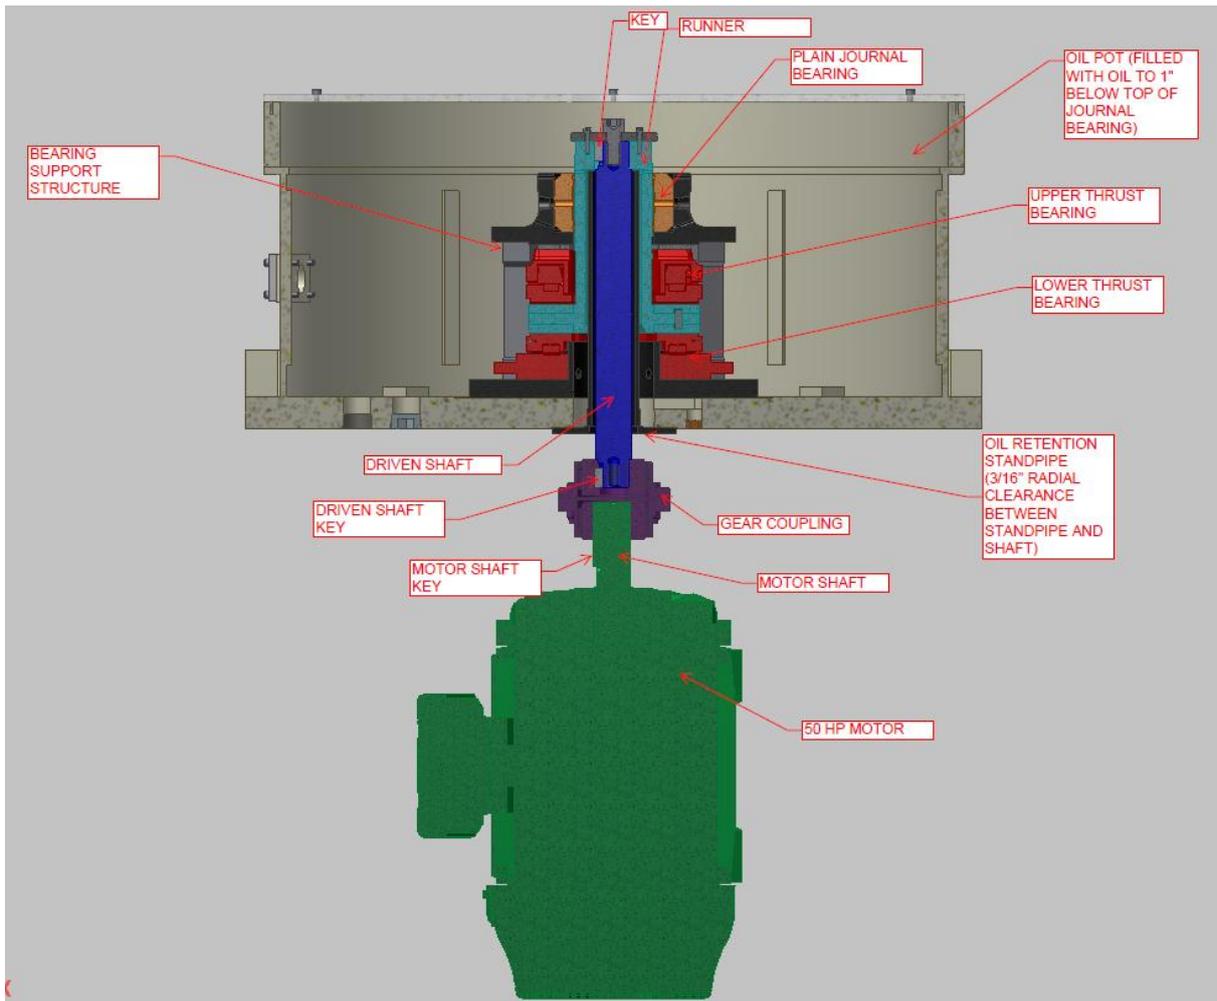
Figure 3. Schematic showing the main components of the vertical test-rig at Kingsbury, Inc.

Additionally, the vertical test rig was used for evaluating the performance of PEEK bearing at lower-speed higher-load conditions compared to the high-speed test rig. The vertical test rig, as shown in Figure 3, is driven by a variable-speed, bi-directional, 50 hp electric motor that is coupled to a vertical shaft that has a non-integral runner with removable runner plates. The runner diameter is 10.625 in (269.875 mm) and has a total thickness of 1.751 in (44.48 mm). A plain journal bearing is used at the top end of the runner for radial positioning.

The thrust collar faces tilting-pad thrust bearing pads on both sides which are custom designed in order to allow adjusting the offset orientation of the spherical shoe support in either a center-pivot, 60% or 40% offset pivot configuration. Hydraulic jacks are placed under each thrust pad of the lower bearing to adjust the load on the bearings, and they also act as a hydraulic equalization mechanism for the lower bearing. The upper bearing utilizes Kingsbury's traditional leveling plates for load balancing between the pads. Removable runner plates allow easy correction of the surface finish during ultimate load tests where the bearings can be pushed to their failure points. The bearings were submerged in a tank as shown in Figure 3 where the lubricating oil was kept at test conditions shown in Table 2 using an external air-based heat exchanger.

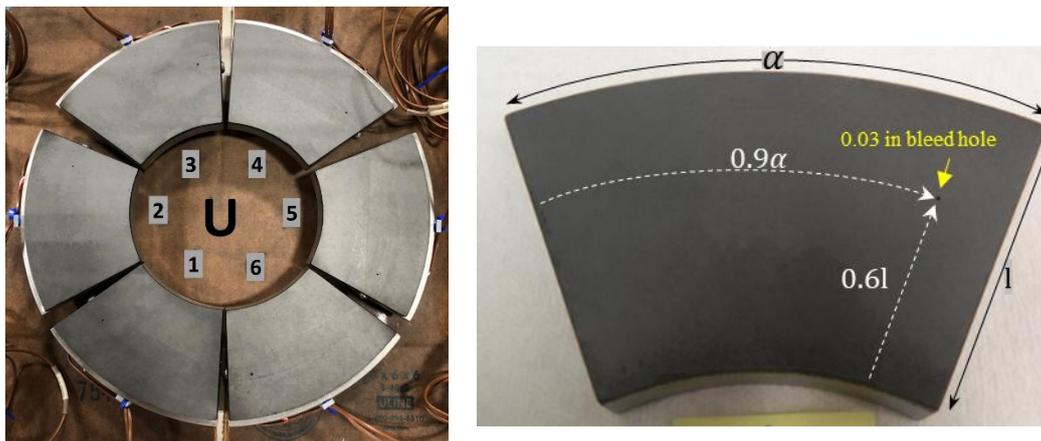
Figure 4. Pictures of the PEEK thrust bearing pads used in the vertical test rig (left figure) and close-up picture of a PEEK pad showing the 'bleed hole' (right figure).

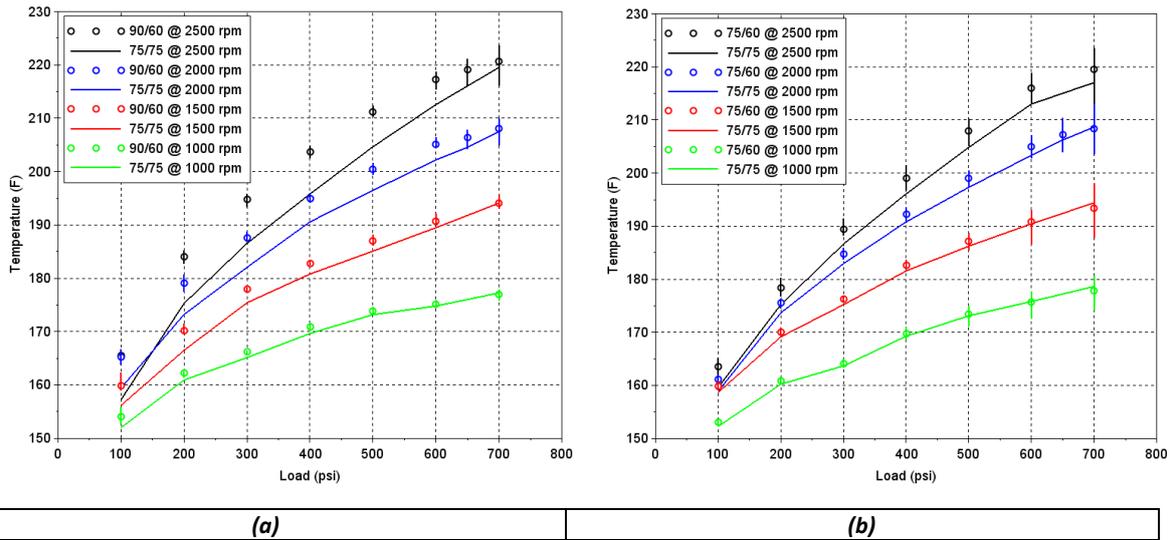
Figure 5. Oil film temperature measurements with the 'bleed hole' at 90/60 vs body sensor at 75/75 position (a) and oil temperature at 75/60 location vs body sensor at 75/75 location (b) with 60% offset pivot babbitt pads.

Figure 5(a) below shows that when the hole is located at 90/60 location on the pad surface, the temperature detected using the hole method matches well with the temperature measured at the 75/75 location. The circular symbols shown in Figure 5 are average of 6 pads and the error bars indicate the variation of temperature between pads. The disparity of temperature between pads is very low and is observed to increase with increase in speed and load with a maximum value of 8 F at 2500 rpm and 700 psi. In the next test, the holes at 90/60 location were puddled in with babbitt and then machined flat and new holes were drilled at the 75/60 locations. It was observed that the gap between the temperatures measured at the 75/75 sensor and the sensor using the hole method decreased while the disparity between the pads have increased as shown in Fig. 5(b). Note that the solid lines in Figures 5(a) and 5(b) demonstrate the repeatability of the test measurements.

The 'bleed hole' measurements shown in Fig. 5 were obtained with a 0.040 in [1.016 mm] hole drilled at the trailing edge side of the pads. It was found that when the side exit hole was closed, the disparity between the temperature measured at the babbitted pads using the hole method at 75/60 location has reduced significantly as shown in Fig. 6(a). The positive effect of plugging the side exit hole has been evaluated for the PEEK lined bearing pads used in the vertical test rig which is also shown in Fig. 6(b). The hole in the PEEK pads were placed at the 90/60 location; however, when the side exit hole was left open the variation of temperature was too large with similar trends in the babbitt pad case where the error bars increased with increase in speed and load. Figure 6(b) shows that when the side hole was plugged in the PEEK pad then the deviation of individual pad temperatures measured with the hole method reduced substantially and the accuracy of the measurements have been improved.

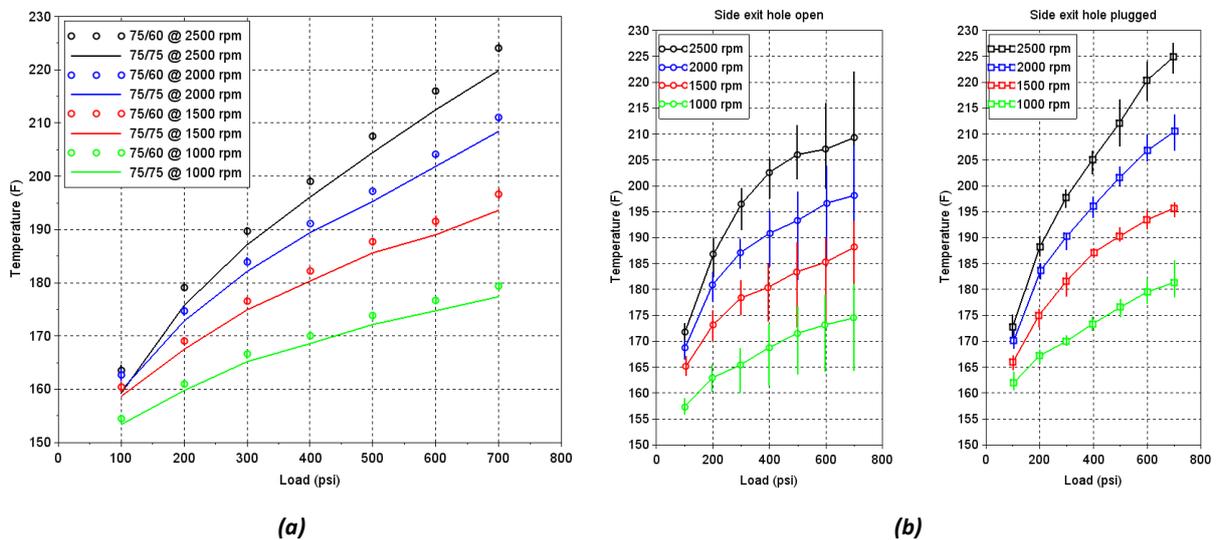
Figure 6. Effect of the side exit hole in temperature measurements with the hole method at (a) 75/60 location in the 60% offset pivot babbitt pad and (b) 90/60 location in the 60% offset pivot PEEK pad in the vertical test rig.

It is important to establish a low variance of pad temperature in the experiments that aim to study the behavior or tilting pad thrust bearings as it indicates a good load equalization behavior of the bearing; however, the relatively larger disparity in the temperature measurements of PEEK pads obtained with the hole method made it more challenging to judge for that effect. The method seems to be more successful with the regular babbitted pads since the babbitt layer is conducting heat into the cavity where the sensor is located, and the transfer of heat is not solely relied upon the small volume of oil that fills the 0.030 in [0.762 mm] bleed hole. Since the conduction through the PEEK layer is significantly reduced then the oil becomes the primary

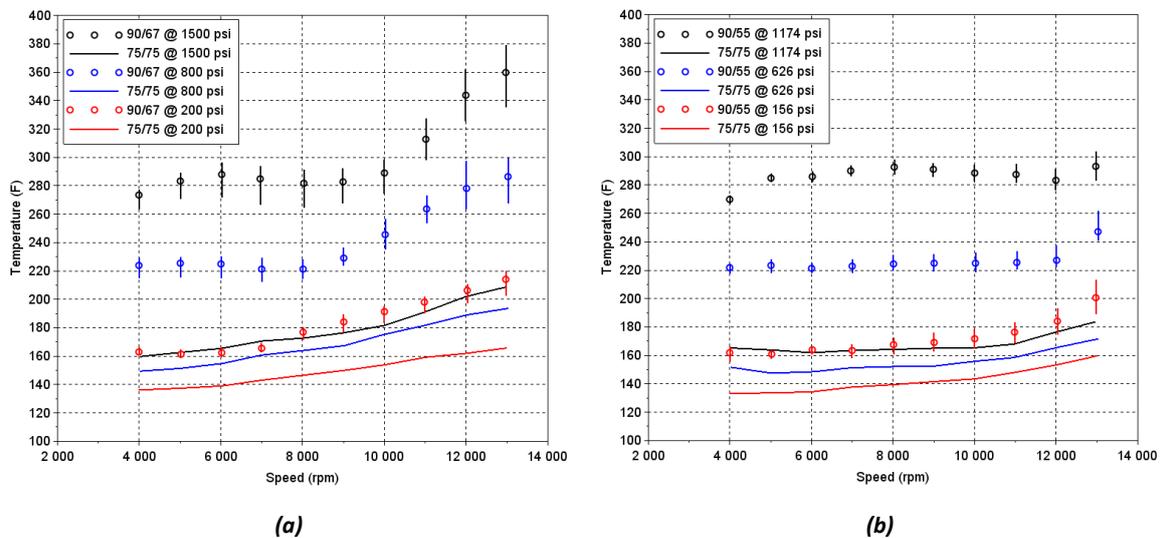
Figure 7. Comparison of film temperature measured using the hole method at (a) 90/67 location in the 'A bearing' PEEK pads and (b) 90/55 location in the 'D bearing' PEEK pads in the high-speed test rig.

Similar temperature measurements obtained with the hole method during steady-state tests at the high-speed test rig are presented in Fig. 7 (a) and (b). It should be mentioned that the side exit hole has not been machined on either of these bearing pads based on the observation in the vertical test rig as shown in Fig. 6(b). As mentioned previously in the experimental set-up section, the first testing campaign with these PEEK bearings only included a 75/75 body sensor under the 0.125 in (3.175 mm) thick PEEK layer, the results of which are also plotted in Fig. 7 for comparison (solid lines). The 75/75 insulated sensors not only show significantly lower temperatures compared to the ones obtained using the hole method, but they also fail in capturing the change in bearing behavior with an increase in speed as seen in Fig. 7 (a), where the 'A bearing' was observed to go through a laminar-to-turbulent transition behavior around 8000 rpm as indicated by the 'bleed hole' measurements, while the trend for the 75/75 temperature shows a steadily rising profile. Similarly, the 'D bearing' is observed to go through a similar transition at 1174 psi case starting at 12,000 rpm which cannot be predicted with the body sensor at the 75/75 location.

The high-speed tests also showed that the negative effect of speed and load on the consistency of the temperature measurements between pads of the same bearing, where the variation of individual pad temperatures from the average value has increased significantly, even with the side exit hole plugged, when compared to the variation of temperature detected in the vertical test rig experiments. This could indicate that the performance of the hole method does not improve meaningfully for a direct lube bearing in contrast to a flooded bearing.

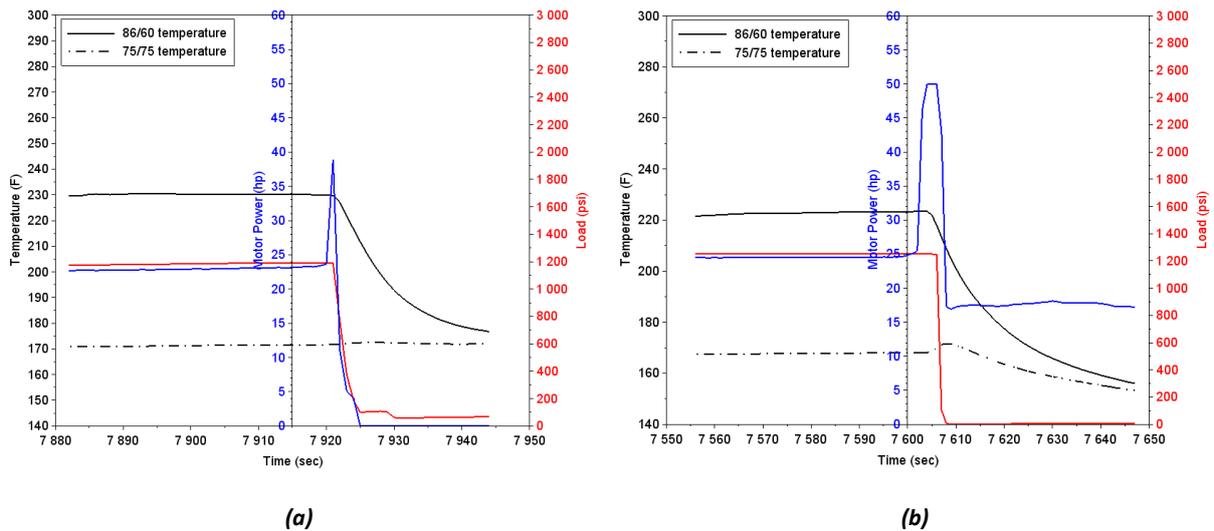
Figure 8. Transient behavior of average pad temperatures of PEEK thrust bearing pads in the vertical test rig for (a) center-pivot position at 2000 rpm and (b) 60% offset pivot position at 1500 rpm during a wipe incident.

The transient behavior of the temperature measurements detected below the 'bleed holes' in the PEEK pads was captured for such events that were purposefully created in the vertical rig when the axial load on the bearings was increased until the rotating runner surface has made contact with the PEEK pad surfaces. Figure 8 shows two examples of wipe incidents for the 10.5" (266.7 mm) flooded tilting-pad PEEK bearing when the shoe support was located at the circumferential center of the pad and when it was located at a 60% offset position in the direction of rotation. The black dashed and solid lines in Fig. 8 represent the temperature

measurements using the hole method at 86/60 location and the sensor within the pad body at 75/75 location, respectively. These measurements were obtained simultaneously during the same experiment. The power consumed by the electric motor was also recorded and is plotted in blue in Fig. 8, while the axial load applied on the bearings is shown in red.

The tests were conducted mainly as a steady-state test until the bearing indicated that it was undergoing distress which for a babbitted bearing presents itself either with a rapid increase in the 75/75 pad temperatures or in the motor power. Figure 8 shows that neither the 75/75 sensor nor the sensor at 86/60 position with the 'bleed hole' were able to detect the local heating caused when the runner made contact with the pads. For the PEEK bearing with center-pivot pads running at 2000 rpm, the recorded motor power increased by about 20 hp before the axial load was decreased, while a similar jump in motor power was observed with the 60% offset pivot PEEK pads at 1500 rpm. The 75/75 sensor in the offset pivot pad was able to pick up a slight increase in temperatures, which was delayed by about 5 seconds when compared to the instant when the motor power spiked.

It can be suggested that during a wipe incident most of the heat generated is conducted through the pad and the rotating collar instead of heating the oil. In addition, the rupture of the oil film during the wipe event could have disrupted the transfer of heat through the 'bleed holes'. Finally, post-wipe assessment of the pads revealed that the PEEK material had melted and smeared over the pad surface in the area of the wipe, with some of the PEEK residue being carried over to the next pad, which has partially or completely clogged the 'bleed holes'.

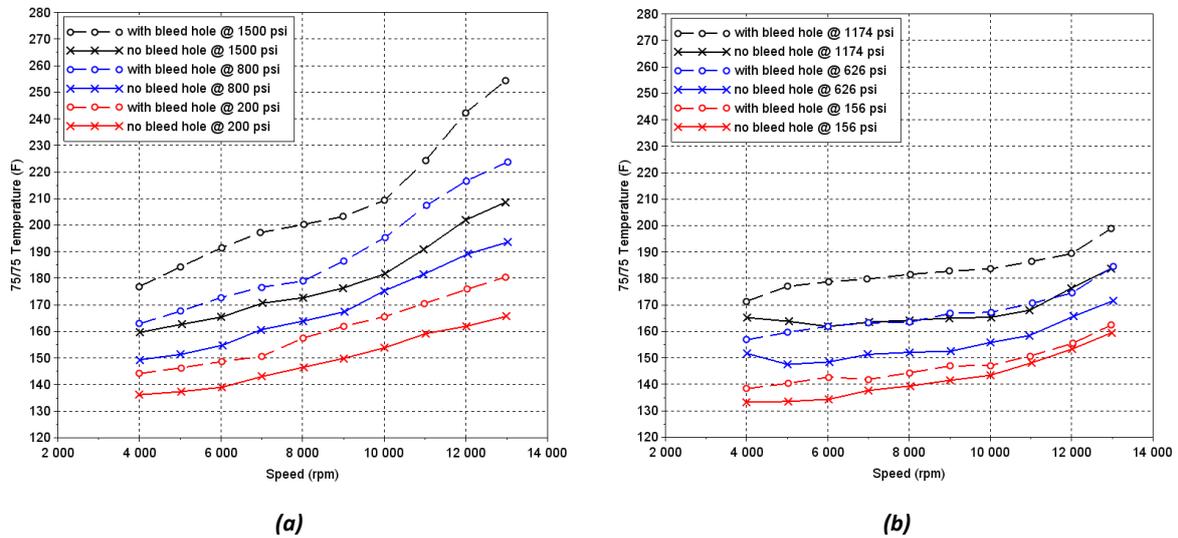
Figure 9. Localized heating caused by the 'bleed holes' in (a) 'A bearing' pads and (b) 'D bearing' pads tested at the high-speed test rig.

In Figure 9 below, the solid lines and the dashed lines present the 75/75 temperatures before and after the 'bleed holes' were placed in the PEEK pads, respectively. Both pads showed an increase in the pad temperatures after the holes were opened in the pads. All the other bearing operation outputs such as the

drain temperatures, power loss, axial shaft position and unloaded bearing temperatures ('B' and 'C' bearings) were similar in the two sets of tests; therefore, it was concluded that the oil entering the 0.030 in (0.762 mm) 'bleed hole' was creating a local hot spot in the pad base metal below the PEEK layer and it was primarily being conducted through the steel pad body laterally and heating up the 75/75 sensors.

Figure 9 shows that the heat transfer from the hot film into the pad body through the leak path created via the 'bleed holes' resulted in an increase of up to 20 F and 40 F in the insulated temperatures detected by the 75/75 sensors in the 'D' and 'A' bearings, respectively. One reason for the higher temperature jump in the 'A bearing' pad sensor is due to the close proximity of the 75/75 location to the 90/67 location as compared to the 'D bearing' pad. The distance between the two sensor locations in the 'A bearing' pad was 0.35 in (8.89 mm) while in the 'D bearing' pads they were apart by 0.68 in (17.272 mm).
