# Hydrodynamic Bearings

A GENERAL GUIDE TO THE PRINCIPLES,  
OPERATION AND TROUBLESHOOTING OF

***Kingsbury, Inc.***<sup>®</sup>

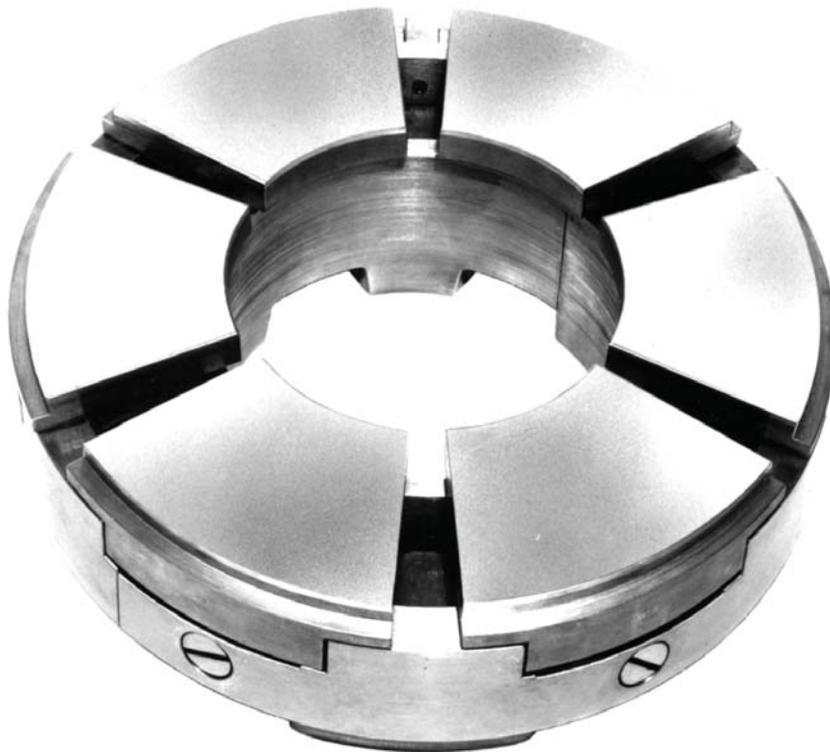
Figure 1 Hydrodynamic, Equalizing Tilting Pad (Pivoted Shoe) Thrust Bearing

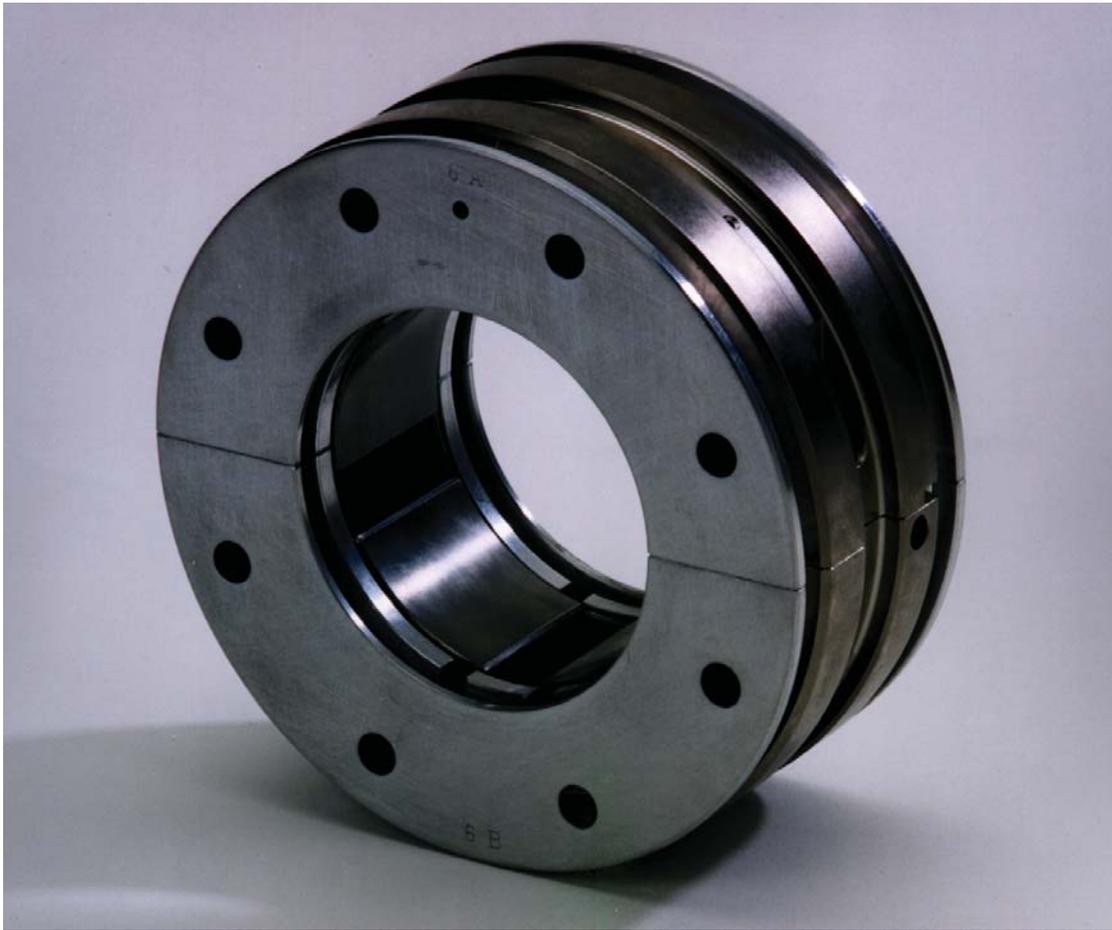
**Figure 2 Hydrodynamic Tilting Pad Journal Bearing**

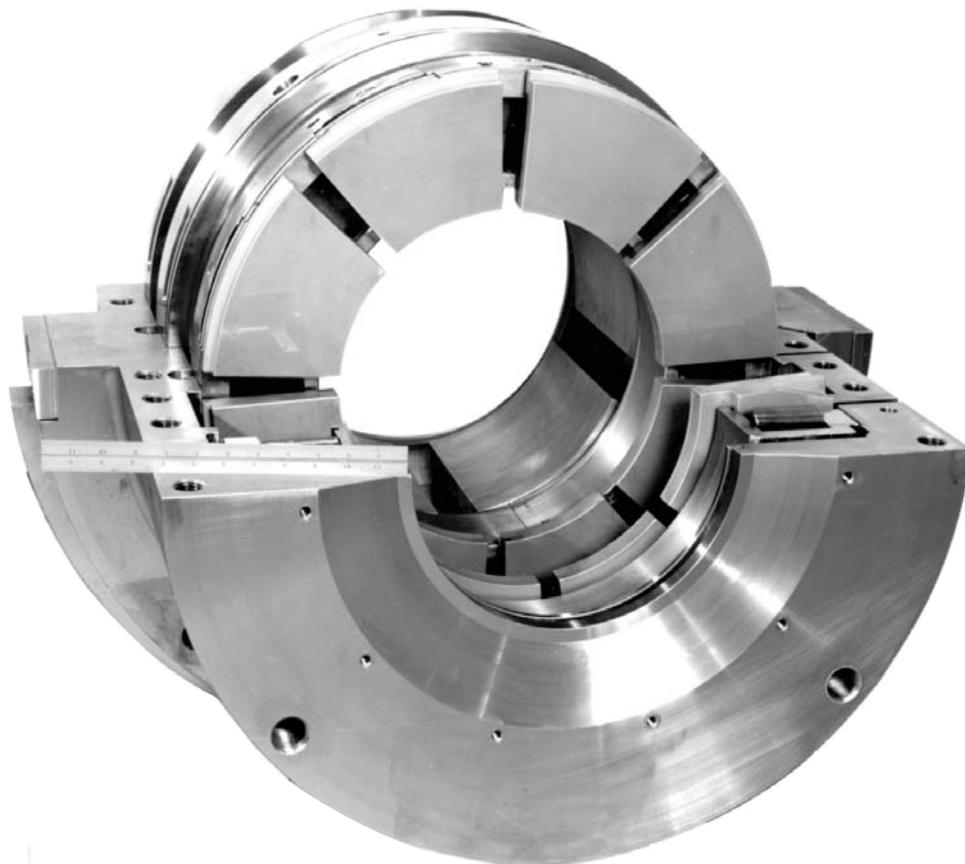
**Figure 3** Hydrodynamic Tilting Pad Thrust and Journal Bearing

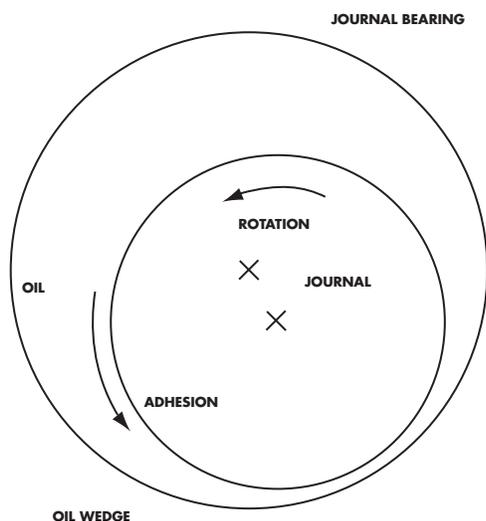
Figure 4 Hydrodynamic Principle

Based on his theoretical investigation of cylindrical journal bearings, Professor Osborne Reynolds showed that oil, because of its adhesion to the journal and its resistance to flow (viscosity), is dragged by the rotation of the journal so as to form a wedge-shaped film between the journal and journal bearing (Fig. 4). This action sets up the pressure in the oil film which thereby supports the load (Fig. 5).

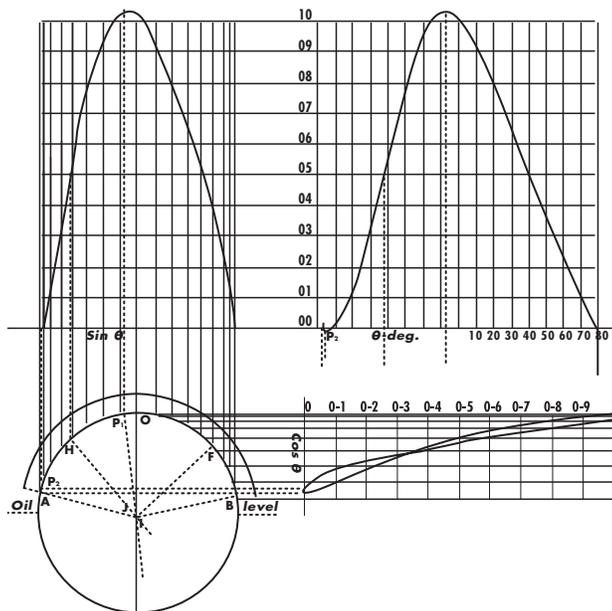
Figure 5 A figure from Reynold's Paper "On the Theory of Lubrication" showing oil film pressure distribution

showed that "if an extensive flat surface is rubbed over a slightly inclined surface, oil being present, there would be a pressure distribution with a maximum somewhere beyond the center in the direction of motion."

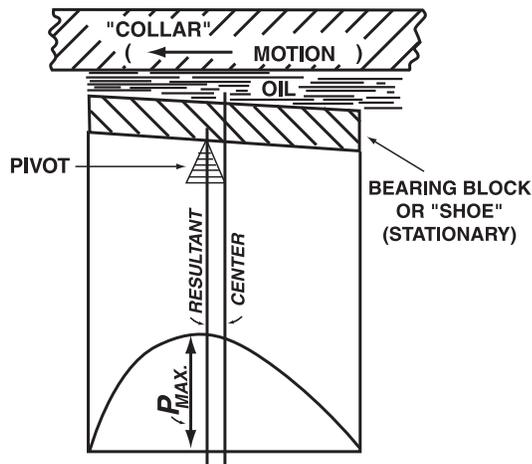
Figure 6 Illustration from a page from Albert Kingsbury's Paper "Development of the Kingsbury Thrust Bearing"

Applied to hydrodynamic tilting pad thrust bearings (Fig. 6) Albert Kingsbury stated: "If a block were supported from below on a pivot, at

about the theoretical center of pressure, the oil pressures would automatically take the theoretical form, with a resulting small bearing friction and absence of wear of the metal parts. In this way a thrust bearing could be made with several such blocks set around in a circle and with proper arrangements for lubrication.” The same concept applies to the tilting pad journal bearing.

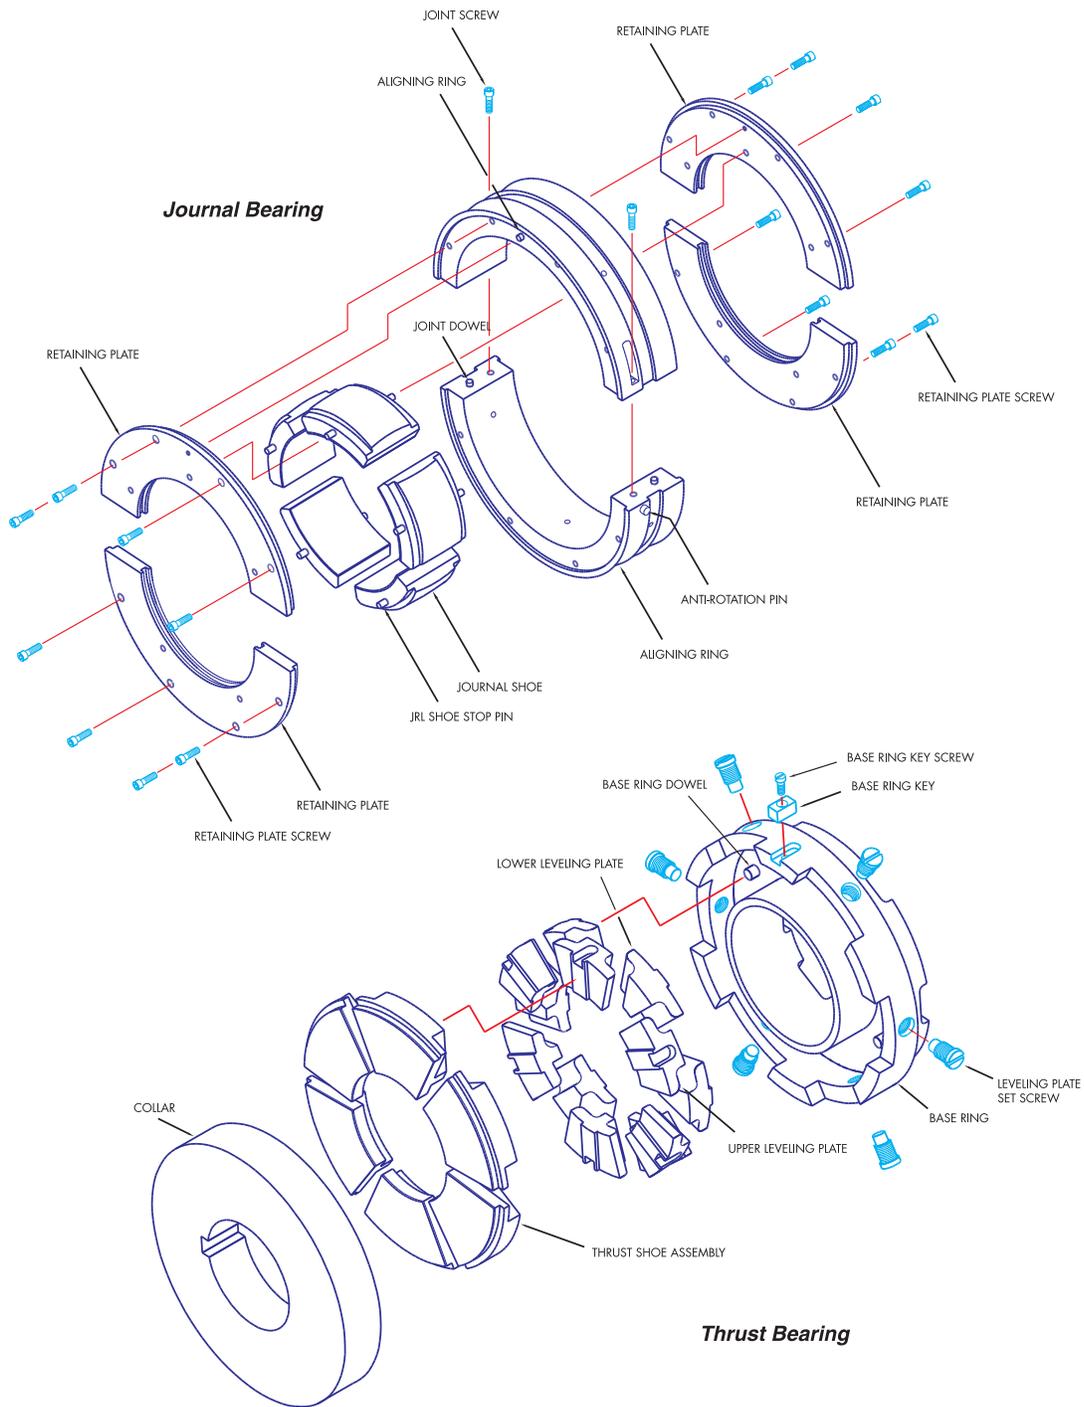
**Figure 7 Thrust and Journal Bearing Part Schematic**

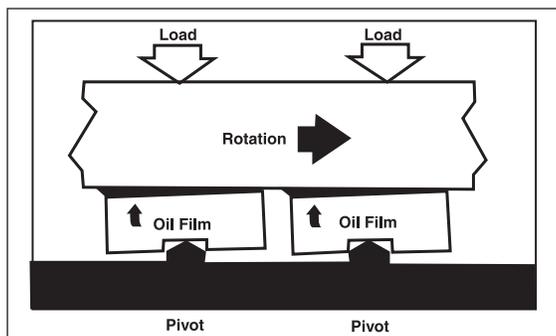
Figure 8-1 Pivoting Shoe Hydrodynamic Film Formation

The lubricant is another important "element" of the bearing (See Fig 8-1). The loads are transmitted from the shaft to the bearing through the lubricant which separates the parts and prevents metal-to-metal contact. The lubricant also serves to carry heat caused by friction out of the bearing.

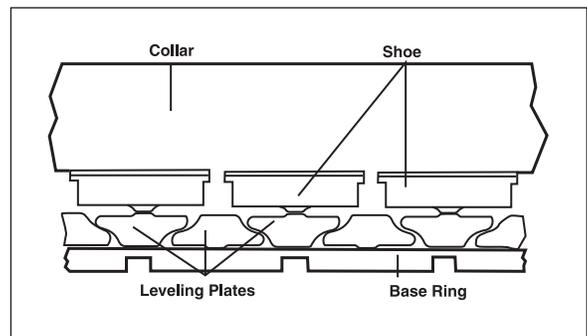
Figure 8-2 Thrust Bearing Load Equalization and Alignment Features

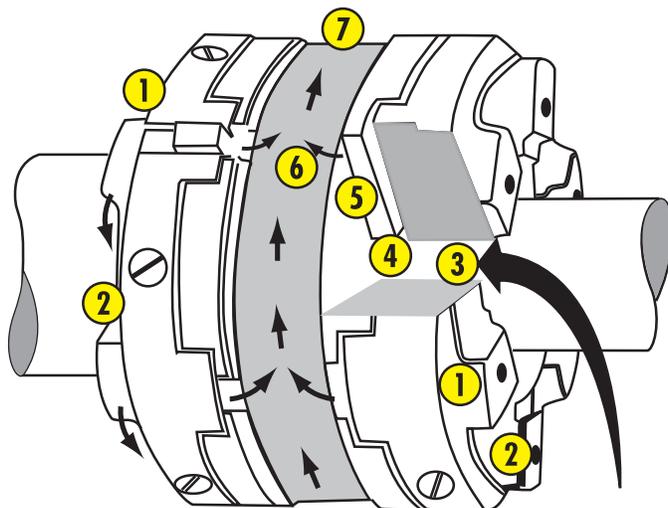
- 1 – Oil enters annulus in base ring.
- 2 – Oil passes through radial slots in back face of base ring.
- 3 – Oil flows through clearance between base ring bore and shaft.
- 4 – Oil flows to inner diameter of rotating thrust collar.
- 5 – Oil flows between shoes and into the films.
- 6 – At the collar rim, oil is thrown off into space around the collar.
- 7 – Oil exits tangentially through the discharge opening.

**Figure 10 Thrust Bearing Typical Oil Flow Path**

Various methods are applied to provide lubricant to the bearing surfaces. The bearing cavities can be flooded with oil such as vertical bearings which sit in an oil bath. The bearings can also be provided with pressurized oil from an external lubricating system. The flow path of a horizontal, flooded **tilting pad** thrust bearing is shown in Figure 10.

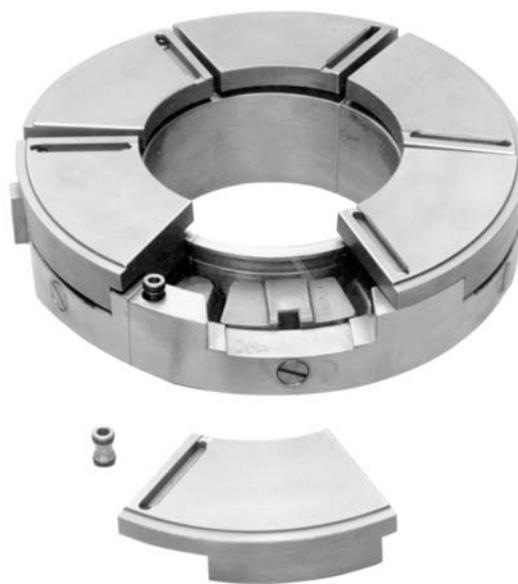
**Figure 11 Leading Edge Groove (LEG) Thrust Bearing**

In 1984 Kingsbury introduced its Leading Edge Groove (LEG) Thrust Bearings (Fig. 11), another technology developed for high tech machines. In addition to reducing oil flow and power loss, LEG lubrication greatly reduces the metal temperature of the shoe surface. This effectively reduces oil flow requirements and power loss while improving the load capacity, safety and reliability of the equipment. Rather than flooding the bearing or wetting the surface, the LEG design introduces cool oil directly into the oil film (Fig. 12), insulating the shoe surface from hot oil that adheres to the shaft. The same technology is applied to tilting pad journal bearings (Fig. 13).

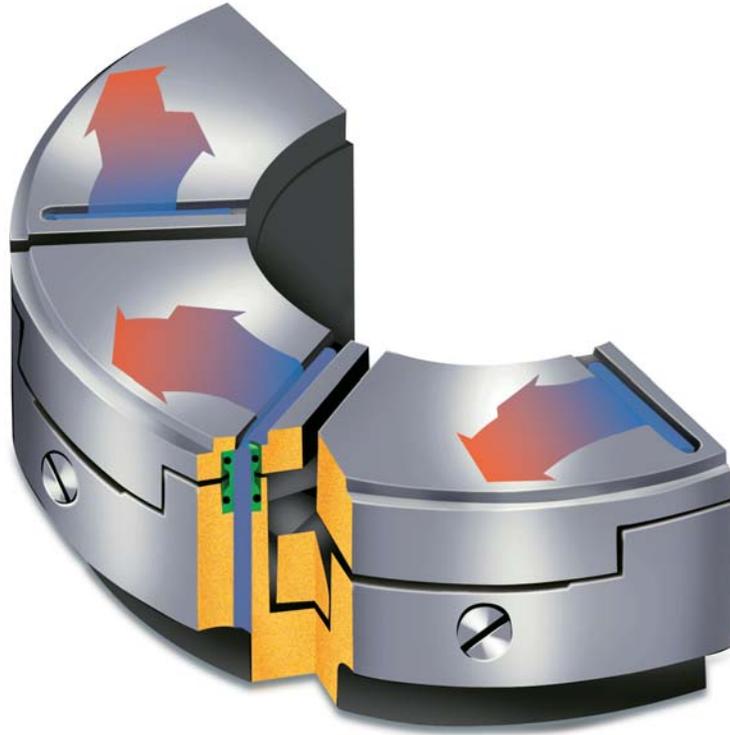
**Figure 12** Leading Edge Groove Lubricant Flow Path.

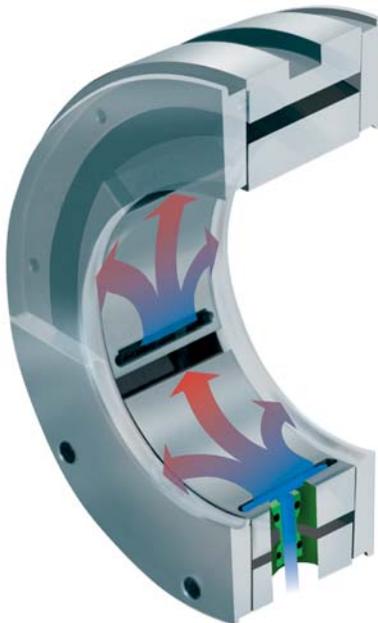
**Figure 13** Leading Edge Groove (LEG) Journal Bearing

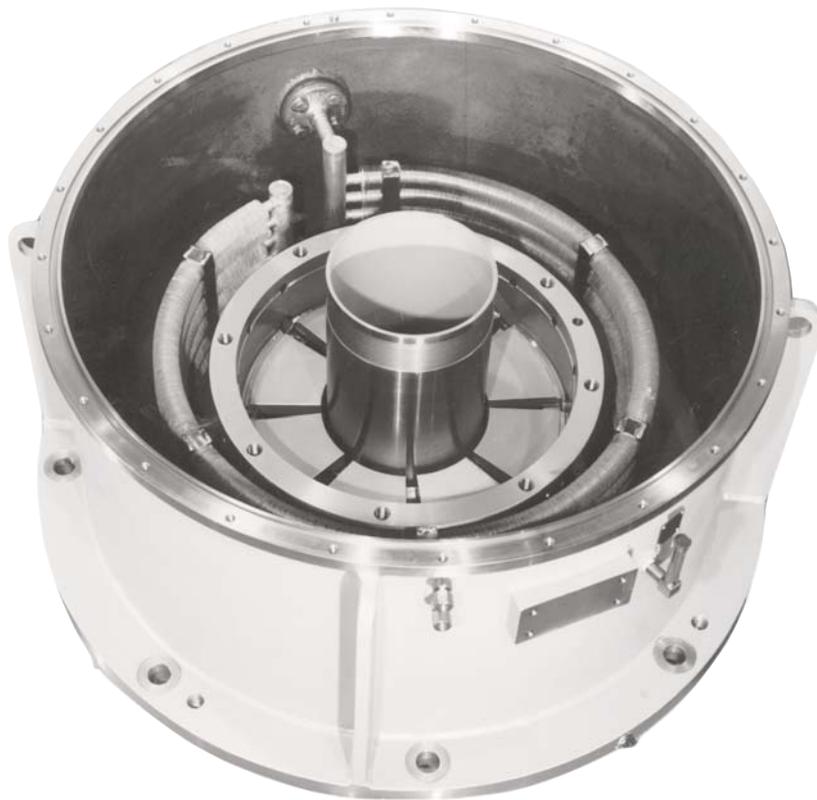
Figure 14 Vertical Thrust Bearing Oil Sump and Cooling Coils

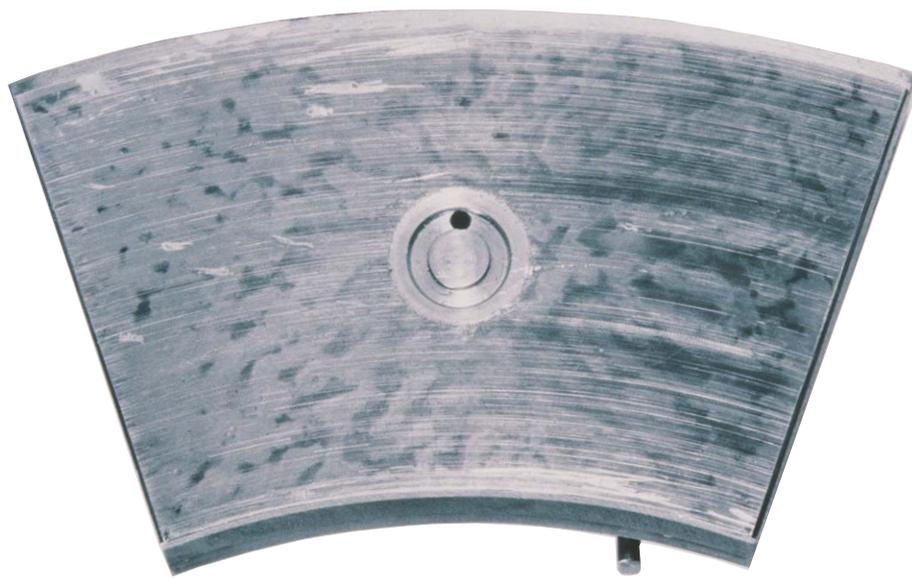
Figure 15 Thrust Shoe Surface Abrasion

A bearing surface exhibiting circumferential scratches is the result of abrasion damage (Fig. 15). Abrasion is caused by hard debris, which is larger than the film thickness, passing through

the oil film. The debris may embed itself in the soft babbitt, exhibiting a short arc on the shoe surface, ending at the point where the debris becomes embedded. Depending on the debris size, the scratch may continue across the entire shoe surface.

Abrasion damage becomes worse with time. Surface scratches allow an escape for lubricating oil in the oil wedge, decreasing the film thickness. This will eventually lead to bearing wipe.

In order to eliminate abrasion damage, the lubricating oil must be filtered. If the oil cannot be filtered or has degraded, it should be replaced. It is important to evaluate the filtering

In addition to filtering/replacing the oil, the entire bearing assembly, oil reservoir and piping should be flushed and cleaned. The original bearing finish should also be restored. Journal shoes typically must be replaced, but if the correction leaves the bearing within design tolerance, the bearing may be reused.

Although the babbitted surface is usually damaged more severely, the rotating collar or journal surface must also be evaluated. Debris partially lodged in the babbitt may score the steel surfaces. These surfaces must be restored by lapping or hand stoning.

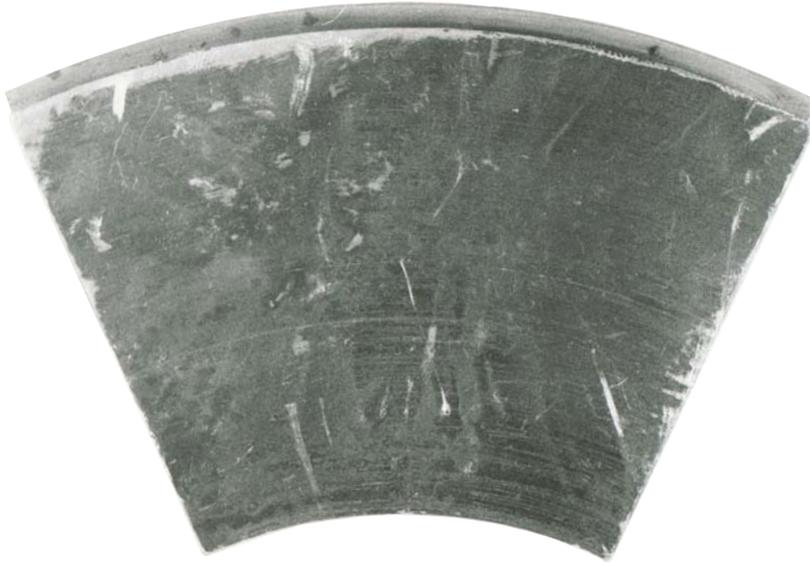
**Figure 16 Tin Oxide Damage**

This is one of several electrochemical reactions which eliminate the embedability properties of a fluid-film bearing. Tin oxide damage (Fig. 16) is recognizable by the hard, dark brown or black film that forms on the babbitt.

Tin oxide forms in the presence of tin-based babbitt, oil and salt water, beginning in areas of high temperature and pressure. Once it has formed, it cannot be dissolved, and its

hardness will prevent foreign particles from embedding in the bearing lining. This allows abrasion damage to occur. Pieces of tin oxide may break off during operation and score the journal, collar, or runner. The formation of tin oxide will also eliminate bearing clearance.

This damage may be stopped by eliminating some or all of the contributing elements. The lubricating oil must be replaced. A reduction in oil temperature may also discourage the formation of tin oxide.

In addition to replacing the oil, the entire bearing assembly, oil reservoir and piping should be flushed and cleaned with mineral spirits. The bearing shoes should be replaced. The condition of the rotating journal, collar or runner surfaces must also be evaluated. They must be restored to original condition, either by lapping, hand stoning or replacement.

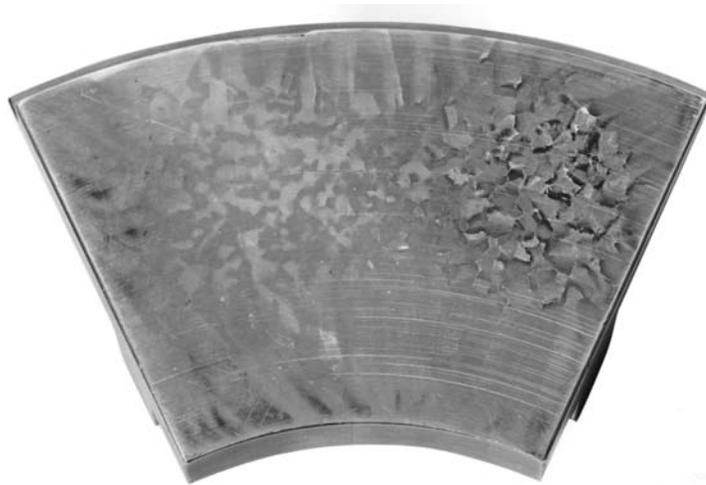
**Figure 17 Thermal Ratcheting**

Overheating damage may represent itself in many ways, such as babbitt discoloration (Fig. 18), cracking, wiping or deformation. Repeated cycles of heating may produce thermal ratcheting (Fig. 17), a type of surface deformation that occurs in anisotropic materials. These materials possess different thermal expansion coefficients in each crystal axis.

If thermal ratcheting has occurred, examine the shoes for the existence and depth of cracks. Remove the cracks and restore the original shoe surface. If this cannot be done, replace the shoes. Journal shoes typically must be replaced, but if the correction leaves the bearing within design tolerance, the bearing may be reused.

The condition of the rotating journal, collar or runner surfaces must also be evaluated. It must be restored to original condition, either by lapping, hand stoning or replacement.

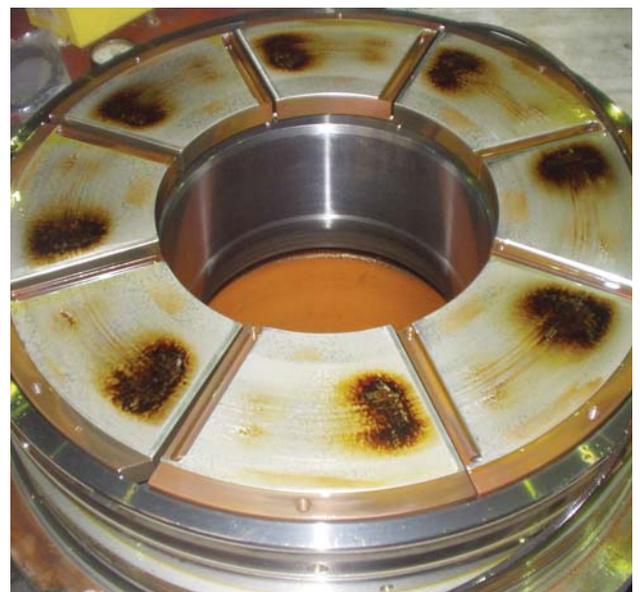
**Figure 18 Overheating, Oil Additives Plated Out**

Verify that the quantity and quality of oil flowing to the bearing is sufficient. These values should be available from the bearing manufacturer.

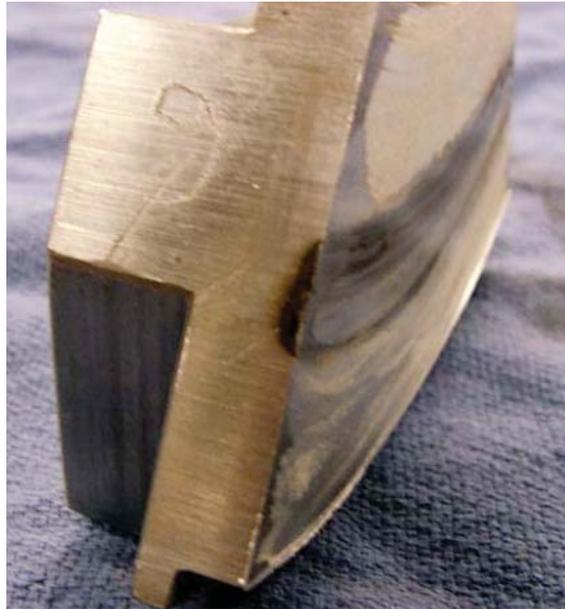
In Fig. 19, the babbitt has been completely removed from the shoe surface. If there had been any oil flow to the bearing, it would have sufficiently cooled the region to allow the molten babbitt to at least solidify and accumulate between the shoes. With no oil coming in at the leading edge of the shoe, this area typically shuts down, resulting in the babbitt being eliminated in the corner near the outer diameter in Fig. 20.

**Figure 19** Tilting Pad Showing Complete Babbitt Removal

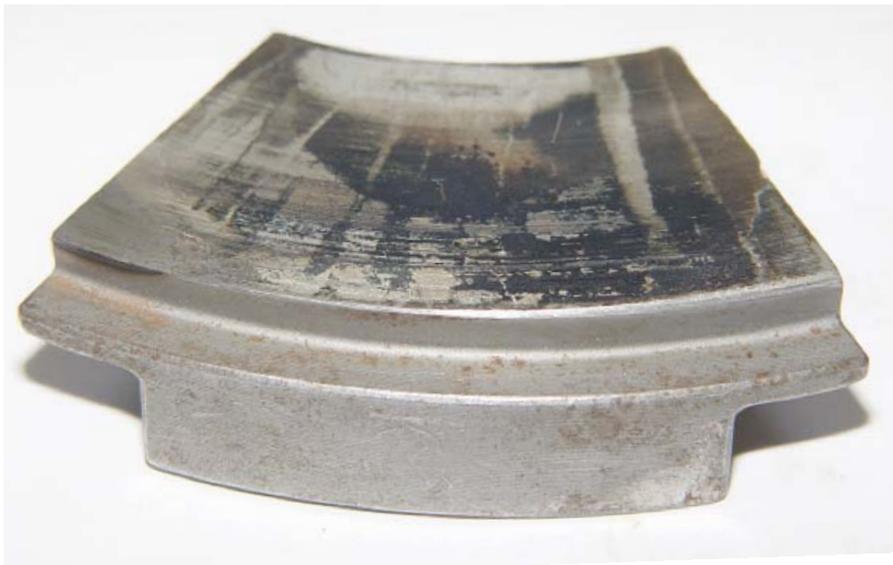
**Figure 20** Outer Edge Babbitt Erosion

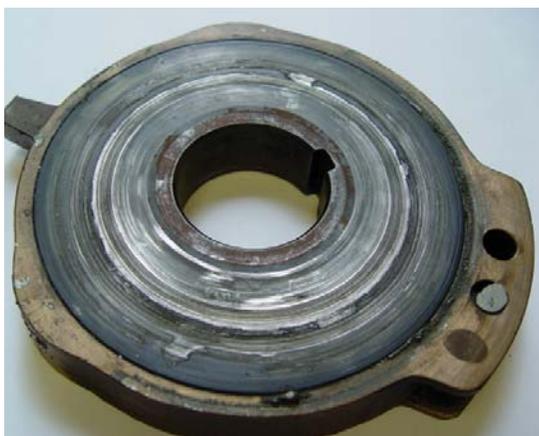
Figure 21 Oil Circulator Fused To Collar

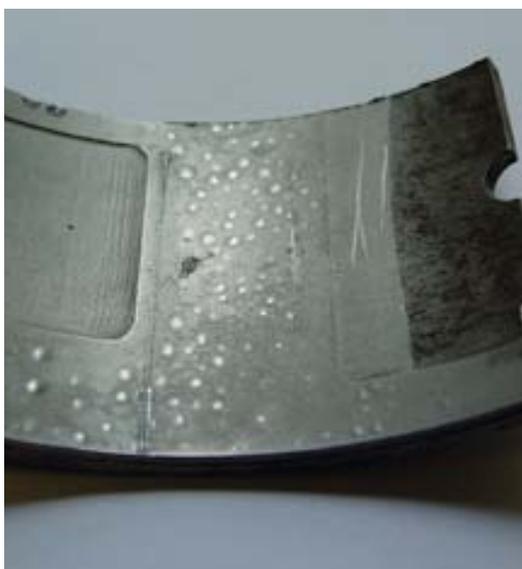
Figure 22 Hydrogen Blisters In The Babbitt

Thermal annealing has been proven to prevent blisters from forming by diffusing out hydrogen before the part is babbitted. In Figure 23, the annealing process was accidentally missed and large hydrogen blisters emerged during the machining process.

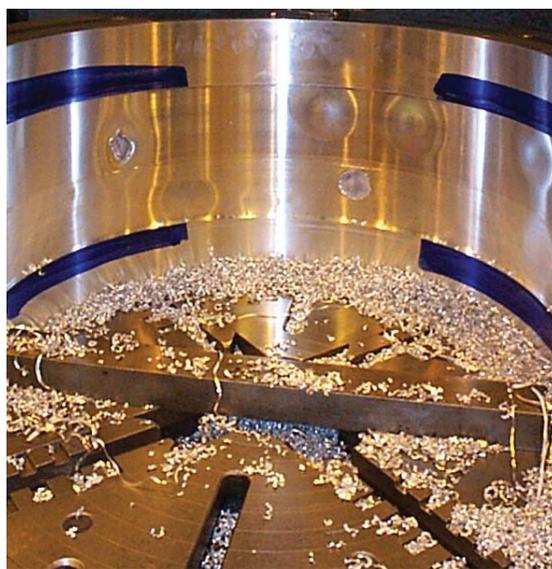
Figure 23 Large Hydrogen Blisters

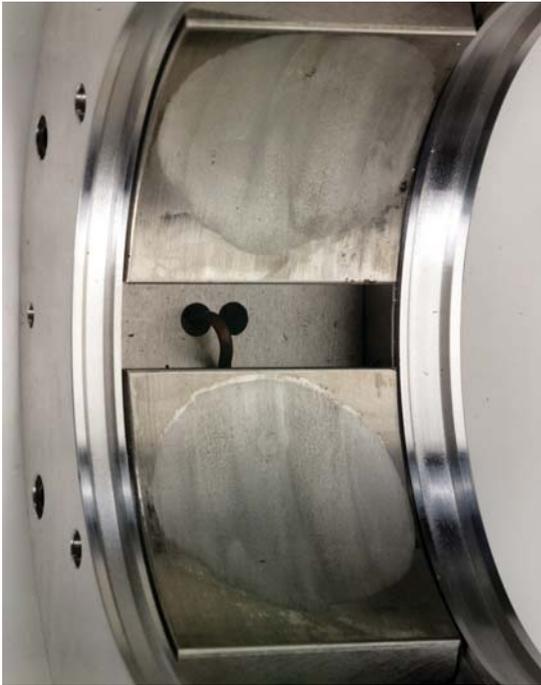
Electrical pitting (Fig. 24) appears as rounded pits in the bearing lining. The pits may appear frosted, or they may be blackened due to oil deposits. It is not unusual for them to be very small and difficult to observe with the unaided eye. A clearly defined boundary exists between the pitted and unpitted regions, with the pitting usually occurring where the oil film is thinnest. As pitting progresses, the individual pits lose their characteristic appearance as they begin to overlap. Pits located near the boundary should still be intact. The debris that enters the oil begins abrasion damage. Once the bearing surface becomes incapable of supporting an oil film, the bearing will wipe. The bearing may recover an oil film and continue to operate, and pitting will begin again. This process may occur several times before the inevitable catastrophic bearing failure.

Electrical pitting damage is caused by intermittent arcing between the stationary and rotating machine components. Because of the small film thicknesses relative to other machine clearances, the arcing commonly occurs through the bearings. Although the rotating and other stationary members can also be affected, the most severe pitting occurs in the soft babbitt.

**Figure 24 Stray Shaft Currents/  
Electrical Pitting (Frosting)**

This type of shaft current can be eliminated with a grounding brushes or straps. Bearing isolation is also recommended.

The lubricating oil must be filtered or replaced. Pitting damage often blackens the oil and fills it

The original bearing finish should also be restored. Journal shoes typically must be replaced, but if the correction leaves the bearing within design tolerance, the bearing may be reused. The condition of the rotating journal, collar or runner surfaces must also be evaluated. It must be restored to original condition, either by lapping, hand stoning or replacement.

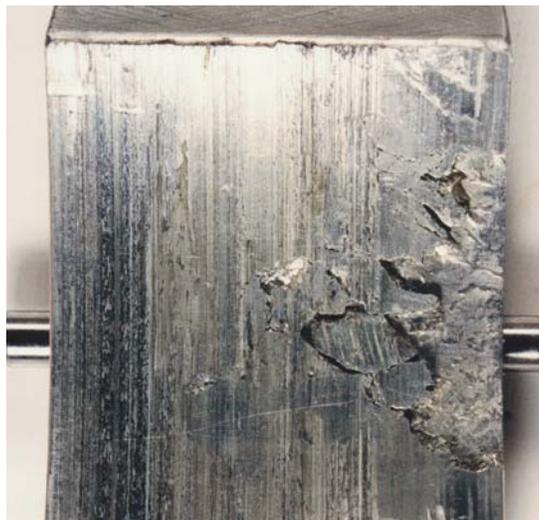
It is important to note that fatigue damage will occur without poor bonding. Fatigue can occur when conditions produce concentrated cyclic loads, such as:

**Figure 25 Edge Load Tilting Pad  
Showing Babbitt Mechanical Fatigue**

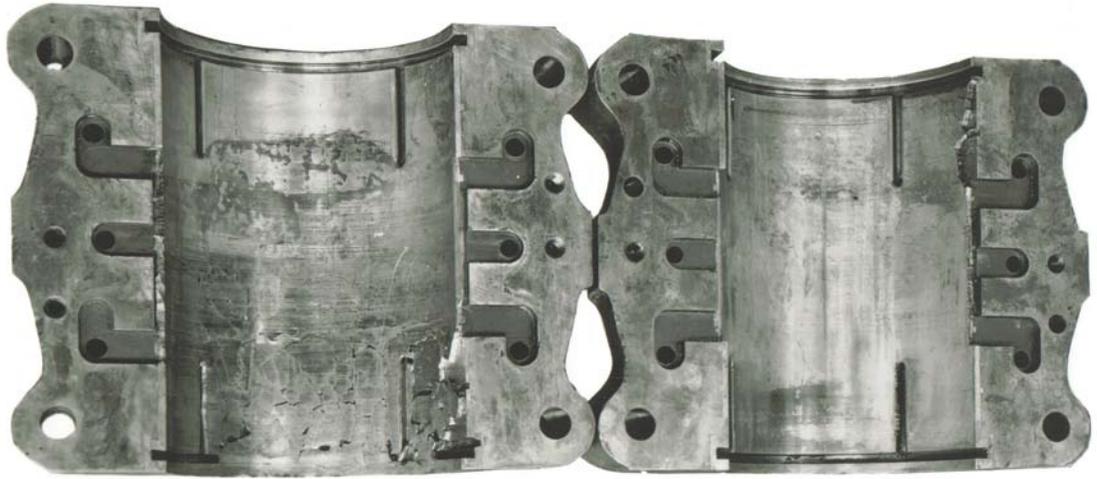
**Figure 26 Edge Load Journal Shell With Babbitt Mechanical Fatigue**

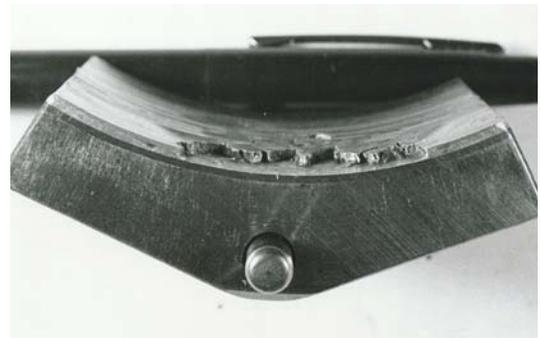
**Figure 27 Fatigue**

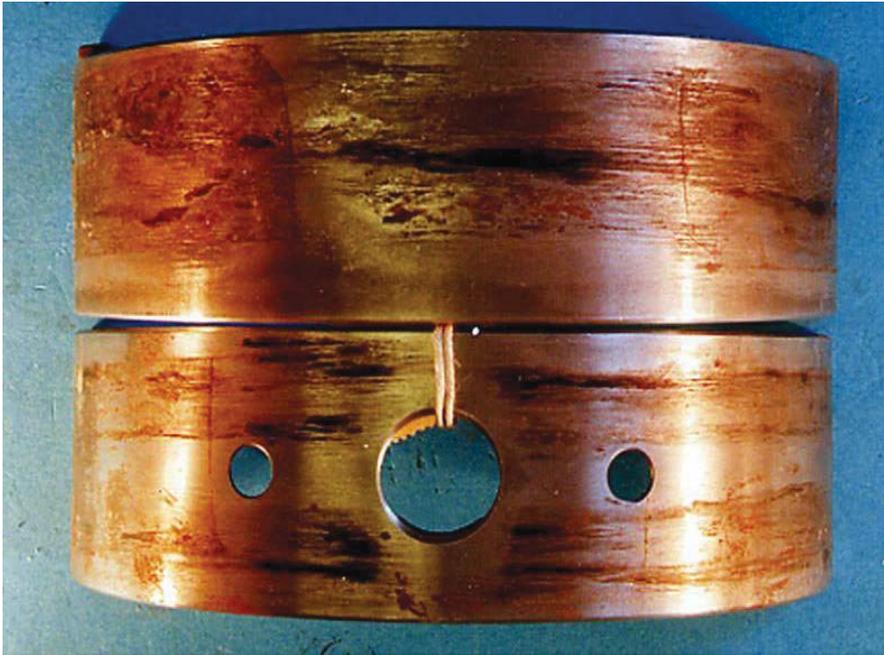
Prime examples are the contact areas between shoe supports and leveling plates, journal bearing shells and the housing (see Fig. 28), and parts with an interference fit, such as the collar and shaft. As can be noted in the photograph, fretting corrosion is characterized by a red-orange iron oxide, which forms on the freshly “machined” steel surfaces. To reduce the risk of recurrence, the replacement parts should be adjusted to obtain a better fit that eliminates the oscillations.

**Figure 28 Fretting Corrosion of Shell And Housing**

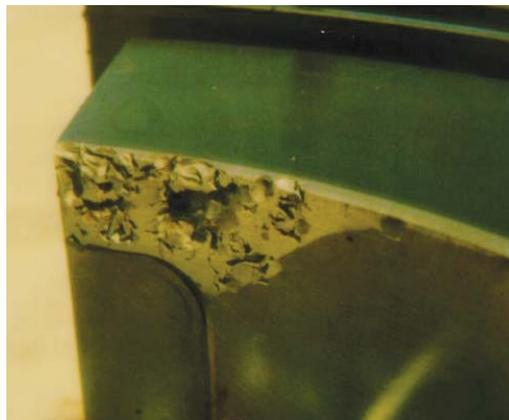
**Figure 29 Eroded Babbitt From Spragging**

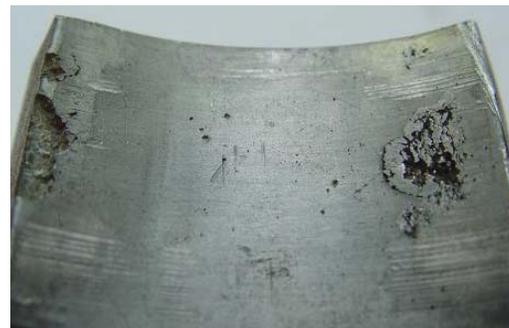
**Figure 30 Spragging Effects On Pad**

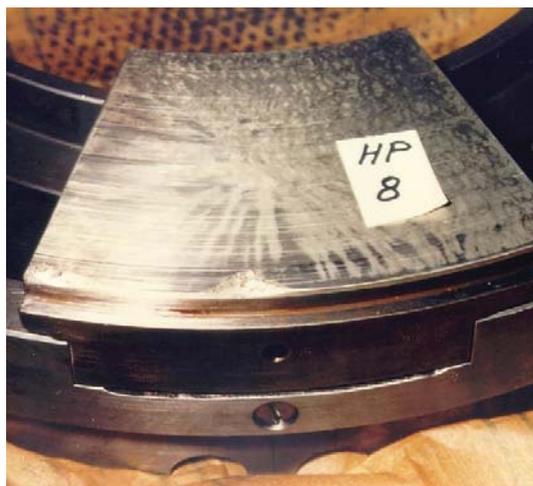
Often called cavitation erosion, cavitation damage (Fig. 32 and 33) is caused by the formation and implosion of vapor bubbles in

areas of rapid pressure change. Damage often occurs at the outside diameter of thrust bearings due to the existence of higher velocities. This type of damage can also affect stationary machine components in close proximity to the rotor.

**Figure 32 Thrust Shoe Cavitation Towards Outside Diameter**

Although the babbitted surface is usually damaged more severely, the rotating collar, runner or journal surface must also be evaluated. This

surface must also be restored to original condition, either by lapping or hand stoning.

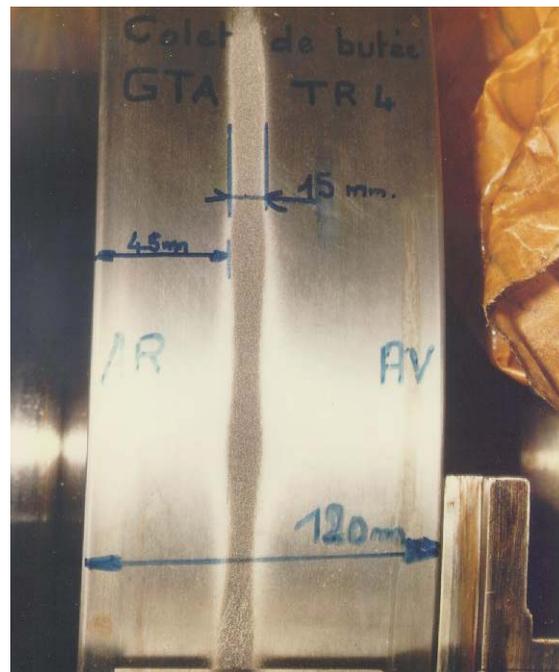
**Figure 33 Cavitation Damage on Outside Diameter of Collar**

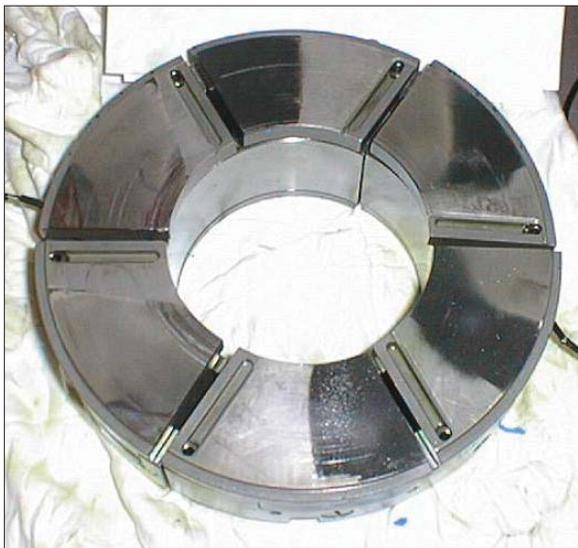
Figure 34 Example of Bearing Corrosion

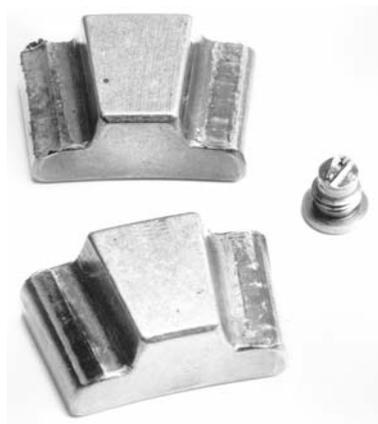
**Figure 36 Leveling Plate Wear Due To Collar Wobble**

If the collar is not within tolerance, the resultant "wobble" (Fig. 36) will force the shoes and leveling plates to constantly equalize, causing rapid leveling plate wear.

It is very important that the collar faces be parallel, and perpendicular to the centerline of the shaft.
