How to Prevent Electrical Pitting Damage

Electrical pitting damage, caused by intermediate arcing between stationary and rotating machine components, erodes the babbitted surface of a bearing, causing it to fail. With the right precautions, however, this type of damage can be prevented.

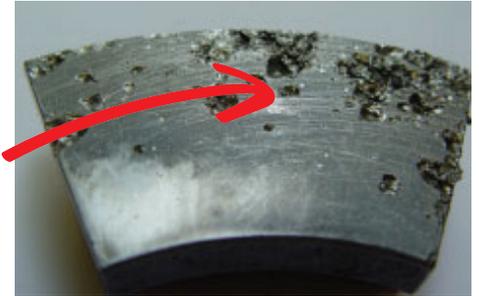
Figure 1

When the bearing was removed from the machine, all thrust pads showed signs of distress, as shown in Figure 1.

Figures 8 and 9 show similar signs of burned oil in the contact area between the shoe's inner diameter and the base ring. The small pit marks and surface frosting observed on the shoes are classic indicators of electrical pitting damage.

This damage is caused by intermittent arcing between stationary and rotating machine components. Electrical current follows the path of least resistance, which is typically through the thin oil films in the active, loaded thrust bearing. Pitting damage initiates at the trailing edge of the shoe, where oil film thickness is smallest.
