Troubleshooting Tilting Pad Thrust Bearings

Machinery Lubrication Magazine
By William Strecker, Kingsbury

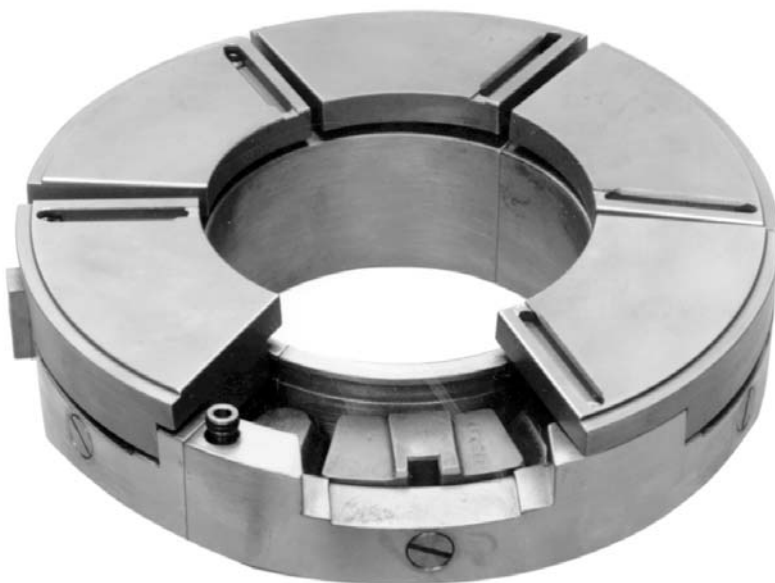
Figure 1. Leading Edge Groove (LEG) Thrust Bearing

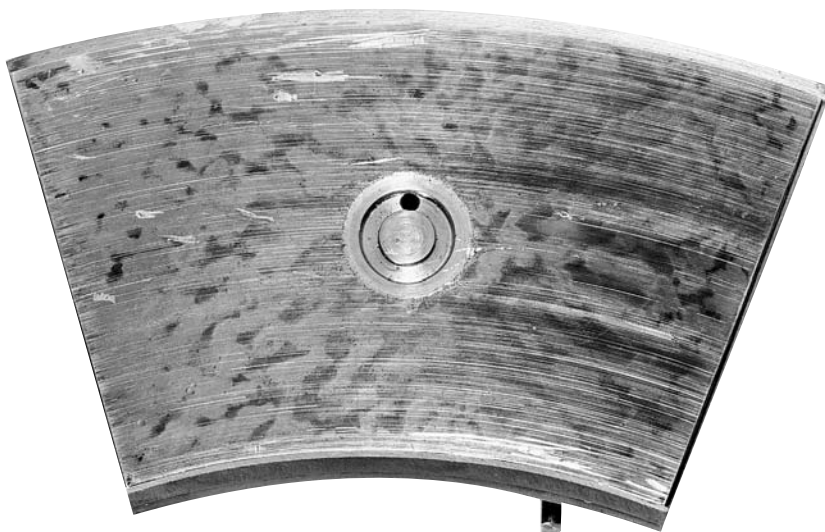
Figure 2. Thrust Shoe Surface Abrasion

Abrasion damage will cause a bearing surface to exhibit circumferential scratches (Figure 2). Abrasion is caused by hard debris, which is larger than the film thickness, passing through the oil film. The debris may embed itself in the soft babbitt, exhibiting a short arc on the shoe surface, ending at the point the debris becomes embedded. Depending on the debris size, the scratch may continue across the entire shoe surface.

Abrasion damage becomes worse as time progresses. Surface scratches allow an escape for lubricating oil in the oil wedge, decreasing

the film thickness. This will eventually lead to a bearing wipe.

To eliminate abrasion damage, the lubricating oil must be filtered. If the oil cannot be filtered or has degraded, it should be replaced. It is important to evaluate the filtering system, because the problem may be an incorrectly sized filter. The filter should pass only debris smaller in size than the predicted bearing minimum film thickness.

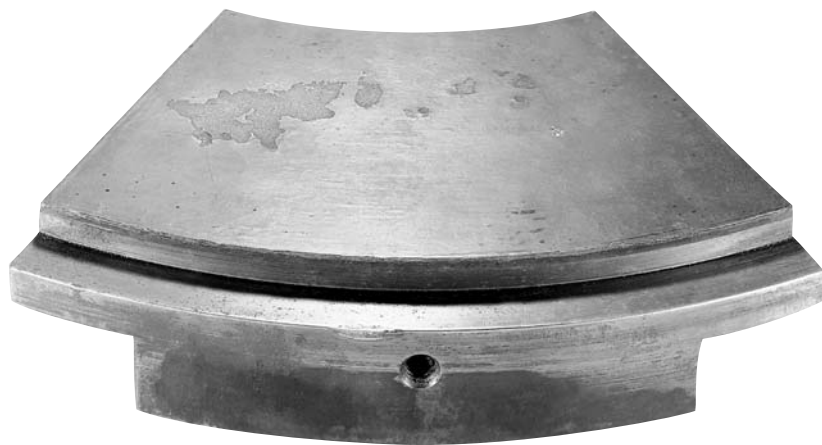
Figure 3. Tin Oxide Damage

Tin oxide damage is one of several electrochemical reactions which eliminate the “embedability” properties of a fluid film bearing. It is recognizable by the hard, dark brown or black film that forms on the babbitt (Figure 3).

Tin oxide forms in the presence of tin-based babbitt, oil and salt water, beginning in areas of high temperature and pressure. Once it has formed, it cannot be dissolved, and its hardness will prevent foreign particles from embedding in the babbitt lining.

This damage may be stopped by eliminating some or all of the contributing elements. The lubricating oil must be replaced. A reduction in oil temperature may also discourage the formation of tin oxide.
